CAPE NEDDICK RIVER WATERSHED BASED PLAN

June 2014

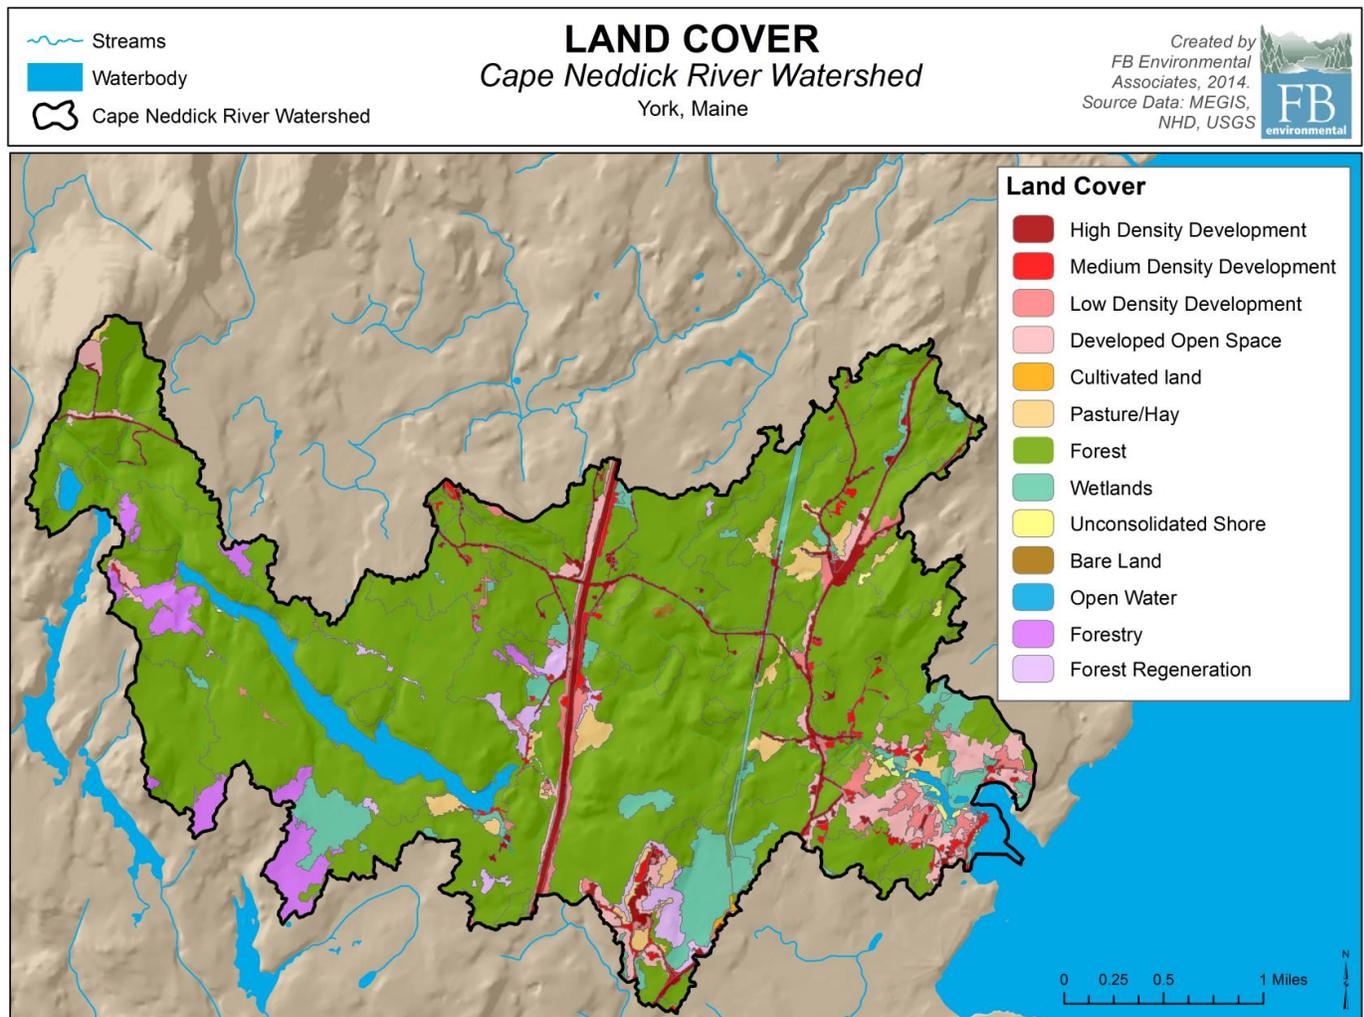
Figure 2-2: Land Cover in the Cape Neddick River Watershed

Based on 2004 Maine Land Cover Data (MLCD), about 77% of the Cape Neddick River Watershed is forested. 11% of the watershed area consists of developed areas including roadways. Wetlands account of just less than 10% of the watershed area, and agriculture contributes 2% land area in the Cape Neddick River Watershed (Figure 2-2).

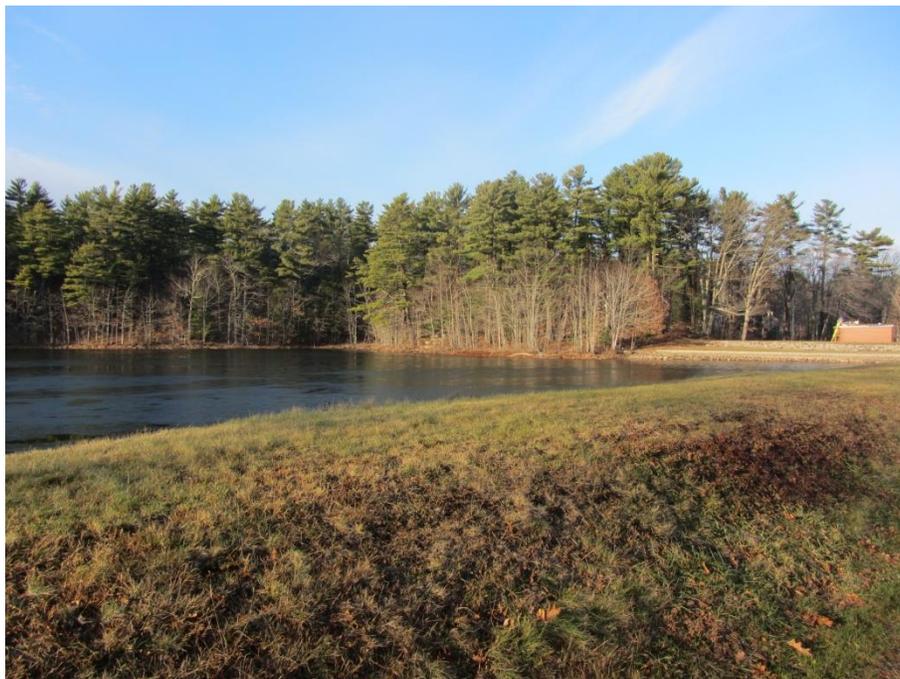
Table 3-3: Maine Healthy Beaches Enterococci Results at Cape Neddick Beach in York, Maine (colonies/100mL)

The Maine Healthy Beaches Program has been testing the Cape Neddick River Beach since June of 2003 using the indicator bacteria, enterococci. The sampling is conducted from June through August to coincide with heavy beach recreational use. The collected data show a trend over the four years towards an increasing number of days per season when enterococci levels exceed the standard and increasing numbers of bacterial colonies in the highest readings. To date, there have been 178 sampling days at the Cape Neddick Beach location (YK-02) with 31 days resulting in bacteria concentrations above the state water quality beach standard of 104 colonies/100mL. Table 3-3 below summarizes Maine Healthy beaches enterococci data at site YK-02 from 2003 to 2013.

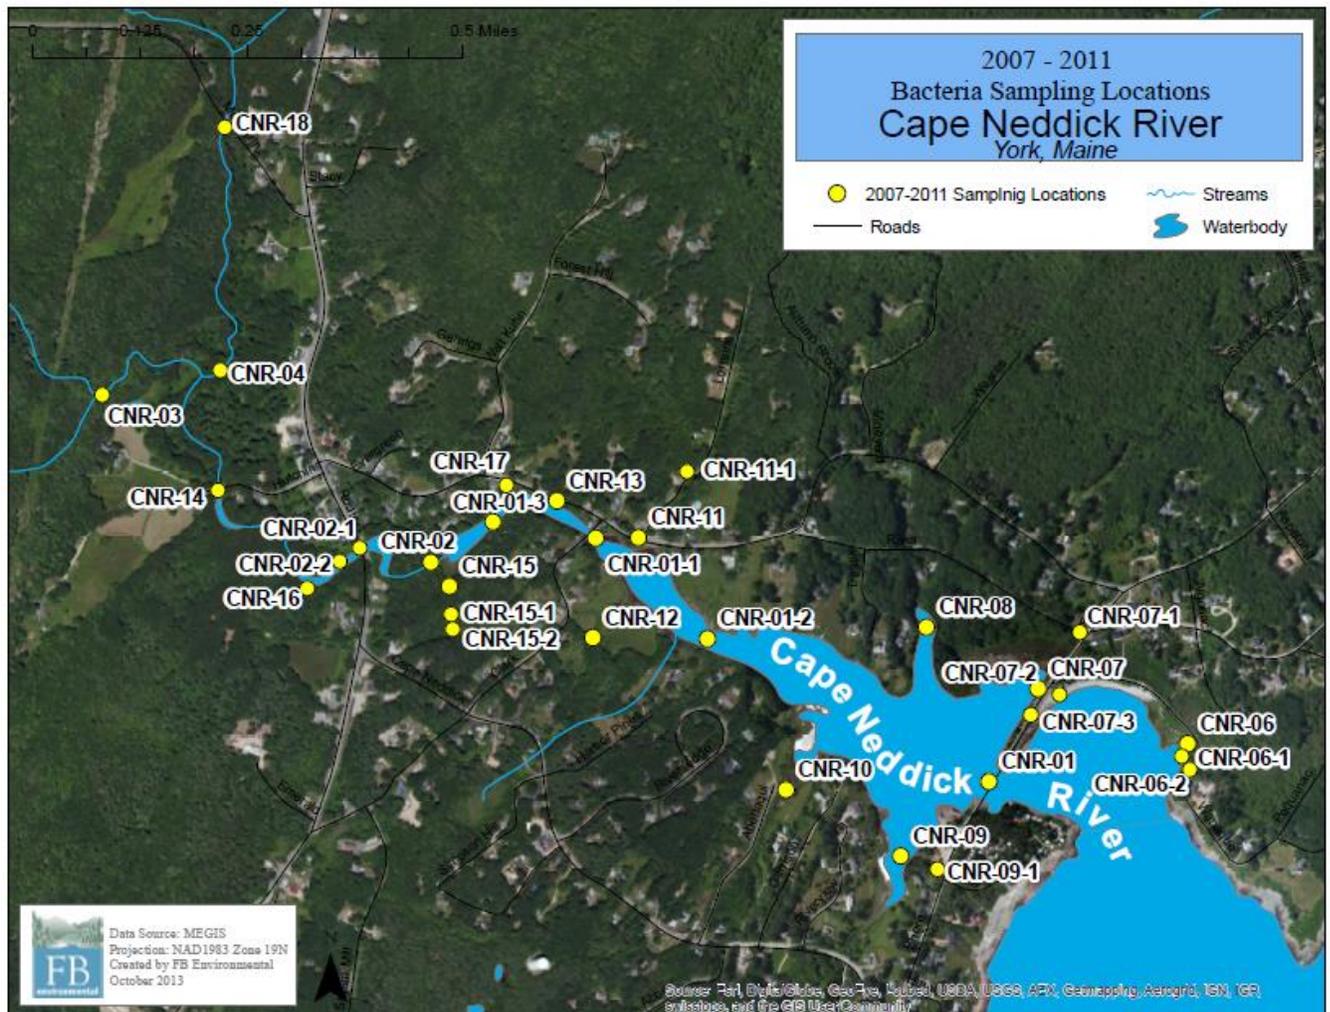
Figure 3-1: Bacteria Sampling Locations in the Cape Neddick River Watershed from 2007 – 2011 (Frick et al., 2013)

In 2008, the sampling expanded to 10 additional tributary locations (designated CNR-06 to CNR-15) and continued in 2009. In 2010, sampling focused on locations CNR-01, CNR -04, CNR -09 and CNR -10, and in 2011, sampling locations were expanded higher up into several tributaries. Figure 3-1 shows the locations where water quality samples were collected from 2007 to 2011.

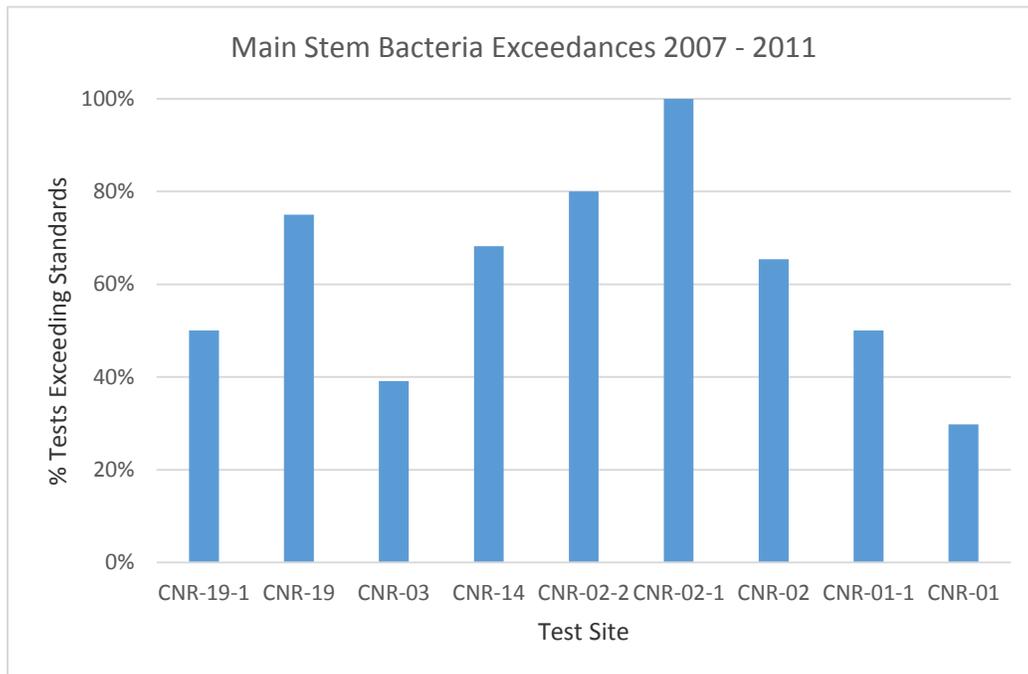
Figure 3-2: Cape Neddick River Main Stem Sample Locations Percent Tests Exceeding US EPA Enterococci Standards from 2007 to 2011(Frick et al., 2013)

The 2007 to 2011 water quality data show that many of the sampling locations had bacteria concentrations that frequently exceeded bacteria standards. Figure 3-2 and 3-3 show the percentage of main stem samples and tributary samples, respectively, that exceeded EPA Enterococci bacteria standards of 61 MPN/100ml in freshwater (for 2007, 2008, 2010, and 2011) and 104 MPN/100ml in saltwater (2007 – 2011) (EPA, 1986). During 2009, the EPA *E. coli* standard of 236 MPN/100ml was used for freshwater tests. These bacteria standards are less conservative (i.e., higher numeric value) than the applicable CNR standards presented in Table 3-1, so the percentage of exceedances shown in Figures 3-2 and 3-3 would actually be higher if the Table 3-1 standards for fresh and saltwater were applied).

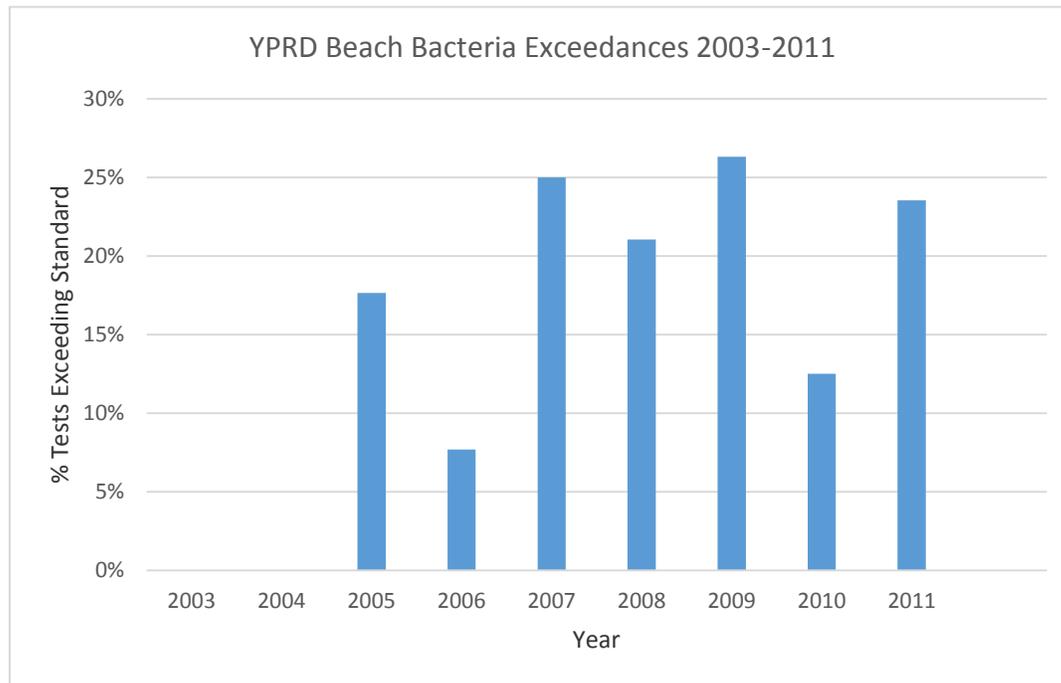
Figure 3-4: York Parks and Recreation Department Bacteria Sampling Results by Percent Exceedance of the Maine Water Quality Standard 2003 – 2011(Frick et al., 2013)

The YPRD has been monitoring water quality at Cape Neddick Beach (and Shore Road Bridge) each summer since 2003. Beach sampling follows MHB protocol. Figure 3-4 shows the percentage of samples annually that exceeded the Enterococci bacteria standard of 104 colonies/100ml from 2003 to 2011. This is the same standard as that listed for Maine Coastal Beaches in Table 3-1. A general overview of these data is provided below.

Review of the overall beach database indicates that rainfall and runoff appear to be a major contributor to bacteria exceedances, but significant rainfall did not result in high bacteria concentrations in every case. Tidal influences may mitigate the effects of bacteria in runoff in some cases.

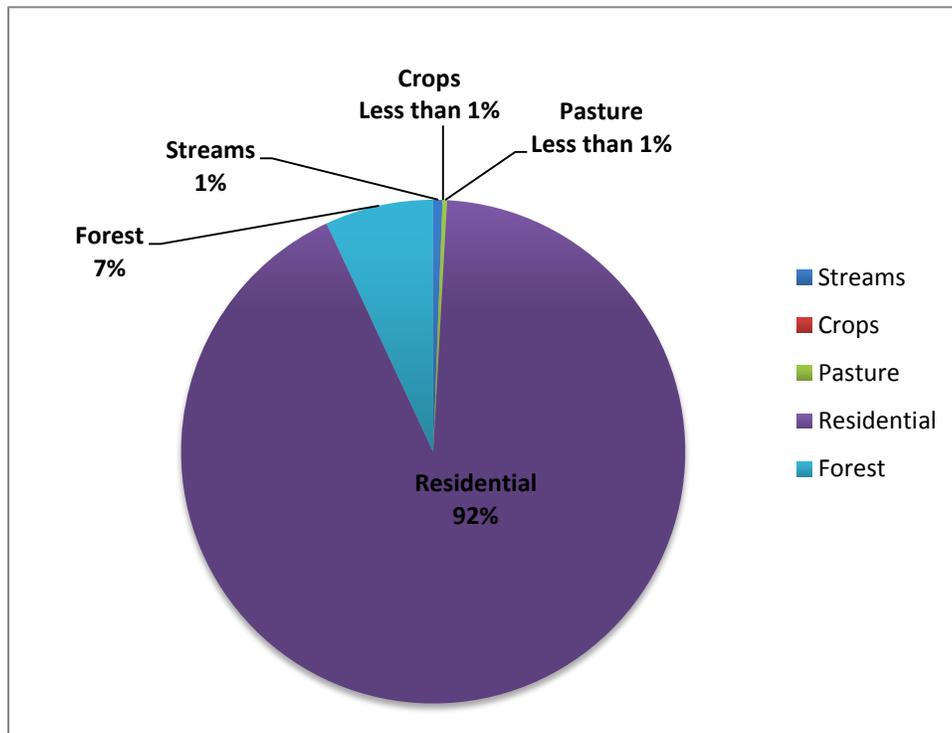
Figure 5-1: Bacteria Source Contributions by Land Use in the Cape Neddick River watershed

Land Use Category	Annual Load (fecal coliform cfu/year)	Percent Contribution
Streams	3.51E+12	0.59%
Crops	2.68E+10	0.00%
Pasture	1.71E+12	0.29%
Residential	5.46E+14	92.2%
Forest	4.12E+13	6.96%
Source Category		
Source Category	Production Breakdown	Percent Contribution
Agriculture	6.14E+11	0.10%
Wildlife	5.08E+13	8.57%
Humans	3.70E+14	62.4%
Pets	1.72E+14	29.0%

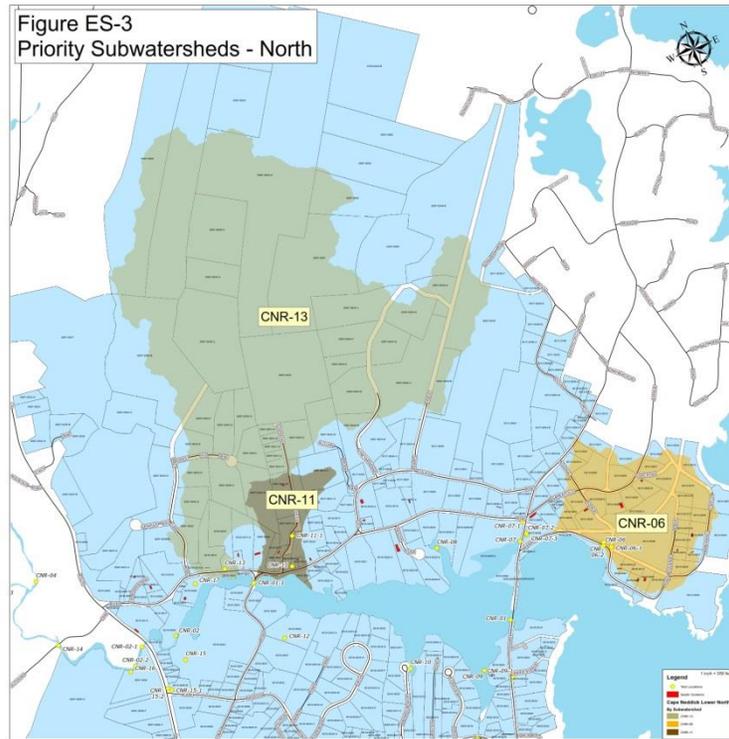
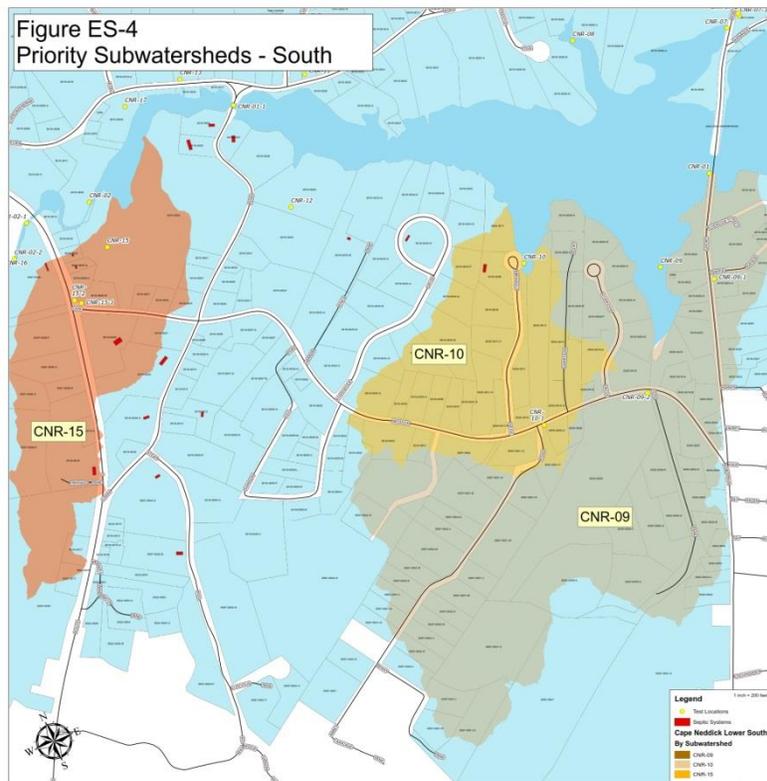
Figure 5-2: Priority Sub-Watersheds in the Cape Neddick River Watershed (Frick et al, 2013)

- *CNR-09 potentially generates the overall largest bacteria load and the largest bacteria load from residential sources (i.e., failing septic systems and pet waste).*
- *CNR-13 potentially generates the second largest bacteria load but the majority of it is from forest sources (i.e., wildlife).*
- *CNR-06, CNR-10, and CNR-15 potentially generate similar bacteria loads, the majority of which are from residential sources.*
- *CNR-11 potentially generates the overall smallest bacteria load.*
- *Humans (i.e., failing septic systems) are potentially the largest source of bacteria loading to the estuary.*
- *Pets are potentially a significant contributor to overall bacteria loading to the estuary.*

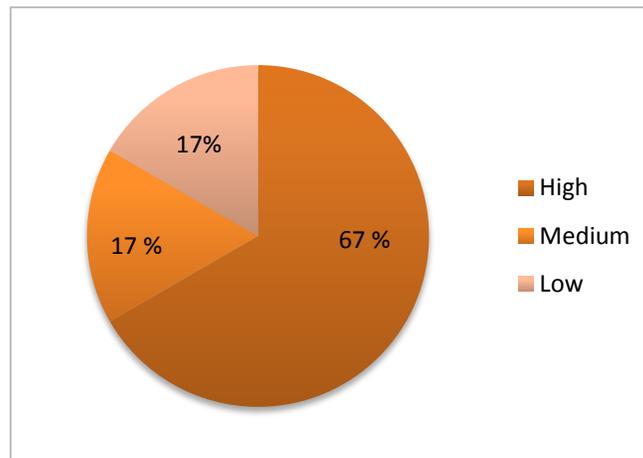
Figure 5-3: Impact Level of Sites in the 2013 Watershed Survey.

Figure 5-2 presents site impact levels documented in the watershed. High Impact sites account for 66.7 % of total 18 documented sites. Both medium and low impact sites account for 16.7 % each. Many of these sites lie in previously prioritized sub-watershed CNR-09 (Figure 5-2).

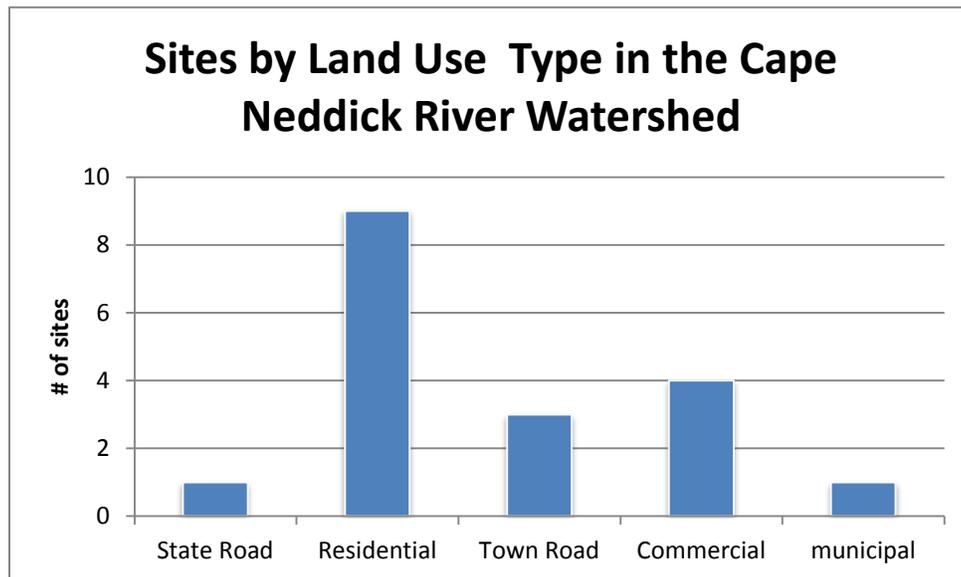
Figure 5-4: Land Use at Sites Observed During the 2013 Stormwater Survey

Nine of the identified sites were found in residential areas and accounted for half of total documented sites. Most of these sites had buffer and shading issues with direct impact to the river. Twenty-two percent of documented sites were found in commercial areas and were mainly related to toxics and impervious surfaces. Road sites account for twenty-seven percent of sites, while municipal areas account for the least amount of sites at five percent of total documented sites. Most road sites were related to impervious surfaces and stormwater drainage. Figure 5-1 presents sites by land use type. Twelve of the eighteen described sites were identified to be of high impact, and was the overall majority. There were three sites described for both medium and low impact (Table 5-5).

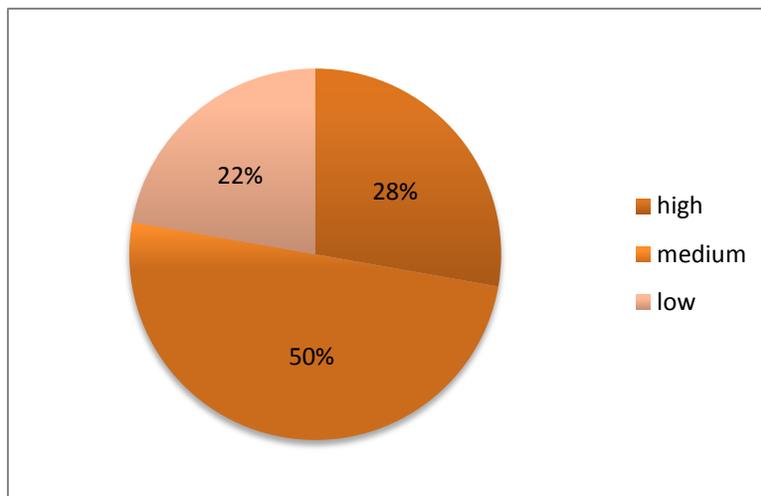
Figure 5-5: Erosion Site Cost Rating from the 2013 Stormwater Survey

Recommendations were made for fixing each site, and the associated cost of labor and materials was estimated (Figure 5-4). Cost is an important factor in planning for restoration and the associated costs of BMP application. “Low” costs sites were estimated to cost less than \$500. 22% of sites were rated low cost. An estimated cost between \$500 and \$2,500 was rated as “Medium.” 50% of sites were rated medium cost (Figure 5-4). If the estimated cost was greater than \$2,500, a “High” rating was assigned. 28% of sites were rated high cost. Appendix A has a detailed summary of the watershed survey.

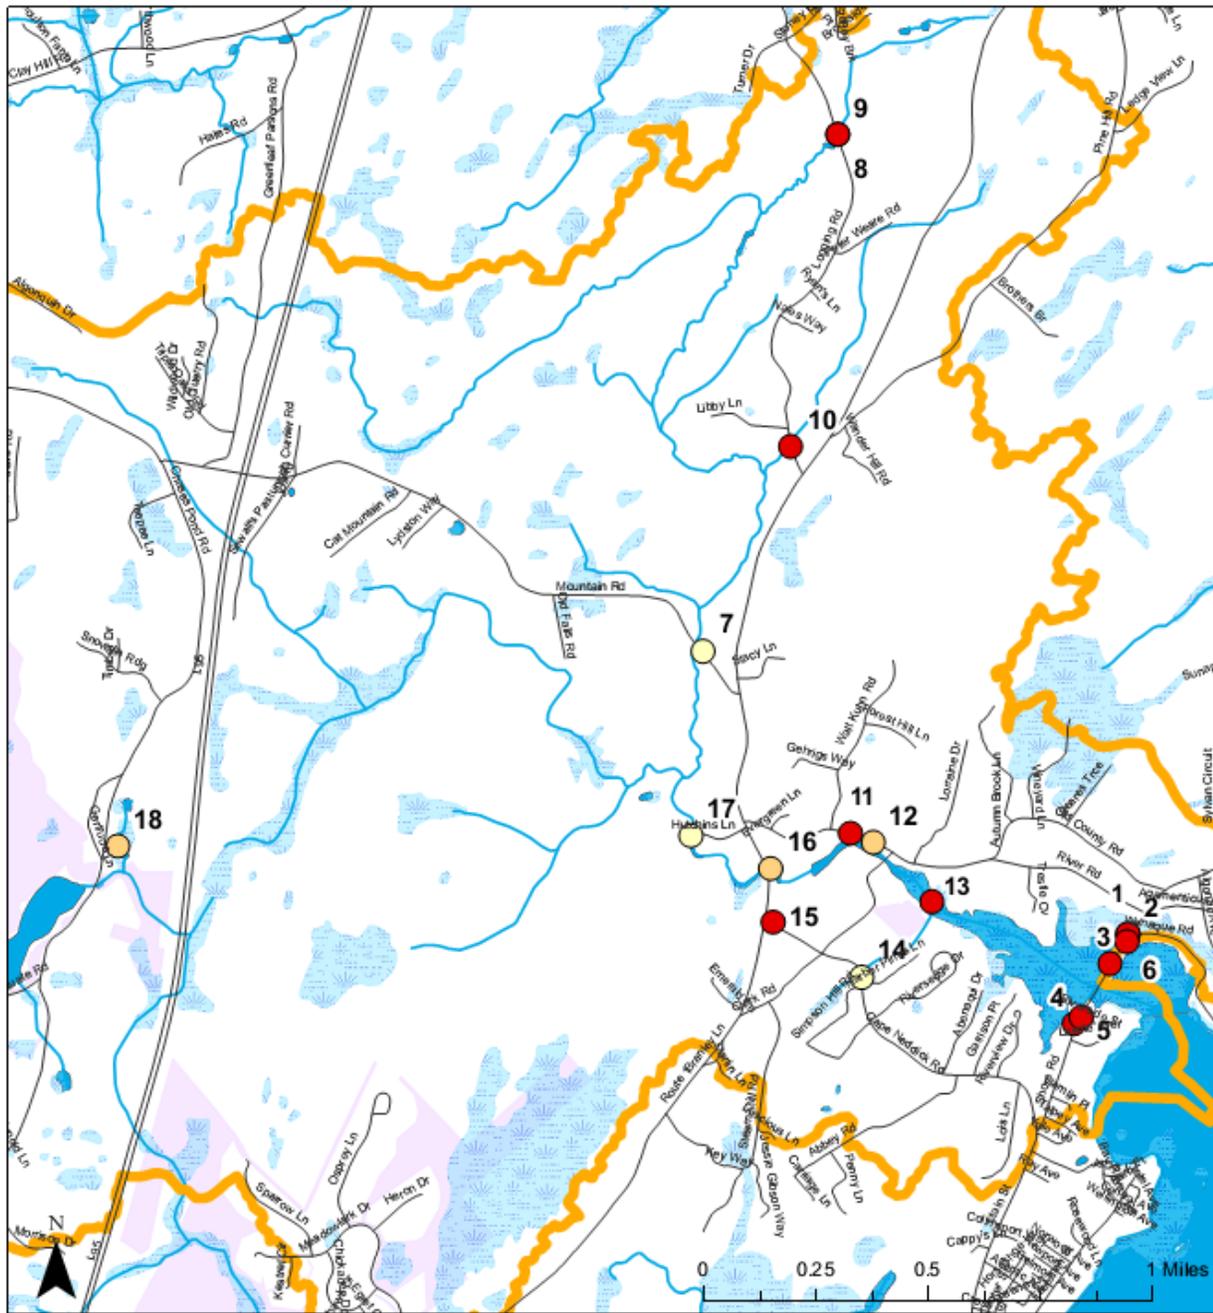
Figure 5-6: Identified Critical Areas in the Cape Neddick River Watershed (a description of each site is located in Table 5-6 and Appendix A)

Cape Neddick River Watershed	Wetlands	Survey Sites by Impact	High
Streams	Roads		Medium
Waterbody	Conserved Lands		Low
